MARITIME HERITAGE MINNESOTA

Phase I Archaeological Reconnaissance of the Big Island Steamboat Pier, Park, and Veterans Camp Site (21-HE-402) Project Report

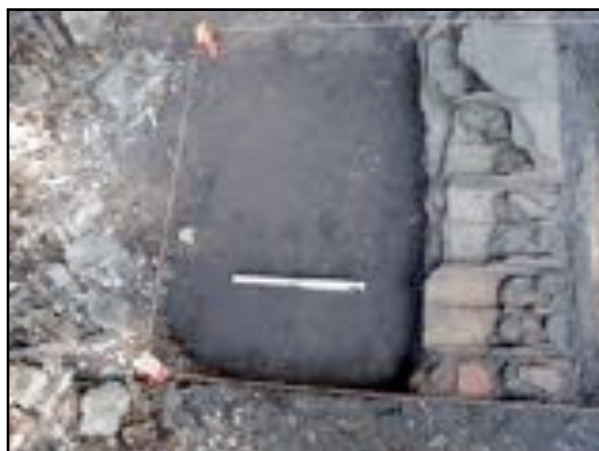
A test trench next to a terra cotta brick and concrete wall near the Figure Eight Roller Coaster, dug in 2003 (MHM).

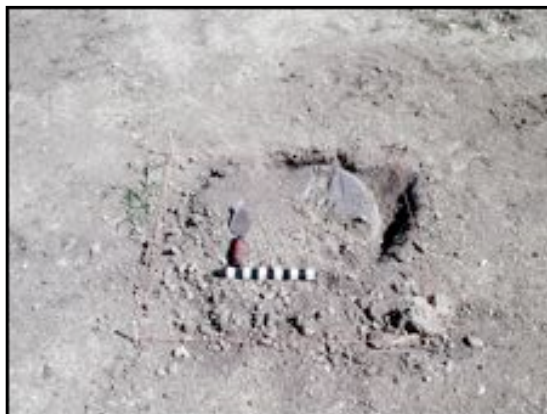
A test trench on the location of the burned BIVC Mess Hall (MHM).

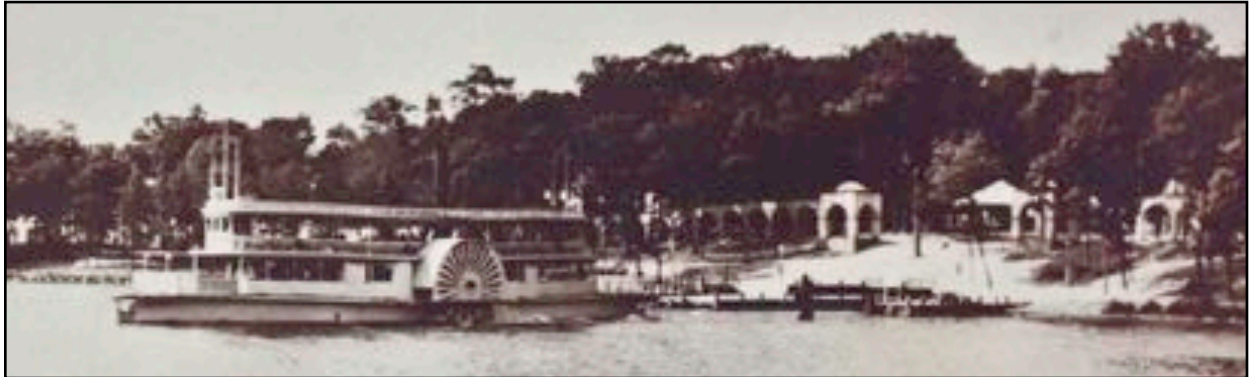
The concrete Landing at the steamboat pier(ELMHS PB12). Insets: The Landing in 2007 and 2019(MHM).

SCUBA, and this will continue. However, the BIAP Steamboat Landing survives, is mostly intact, and when approaching the project area by boat, is the most obvious component visible. Originally comprised of 6 foot by 6 foot poured concrete slabs, the surviving area measures 57.50' by 114.00' feet at its longest point near the shore. Some of the Landing along the shoreline partially survives because of erosion and rip rapping. The Landing was designed with 1 circular area left unpaved, and a tall tree once grew there; that area is still evident. The Landing Stairs survive - although they have been damaged in recent years - and are 63.50 feet long, 5.80 feet wide, and are comprised of 4 steps. On either side of the stairs, two Gazebo Bases remain *in situ*.

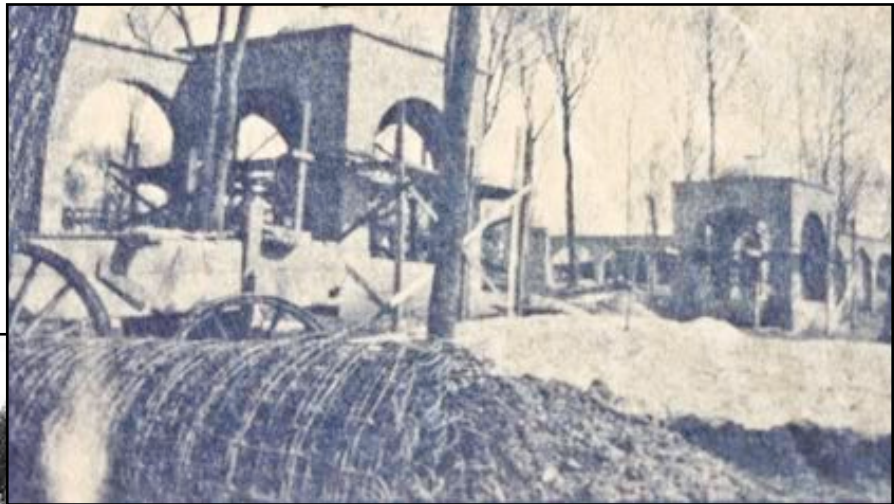
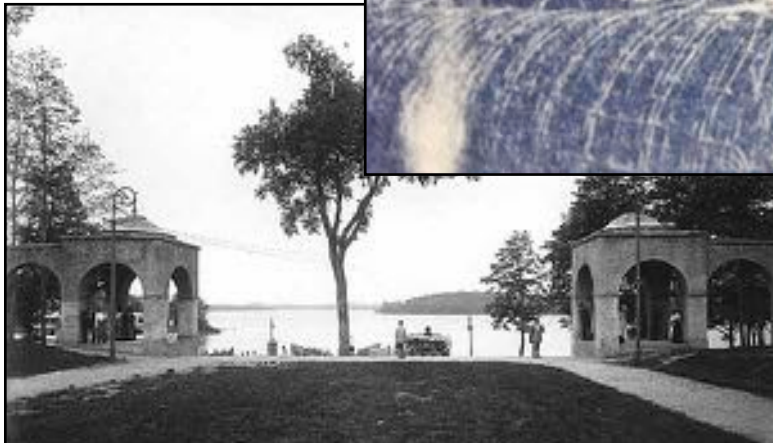
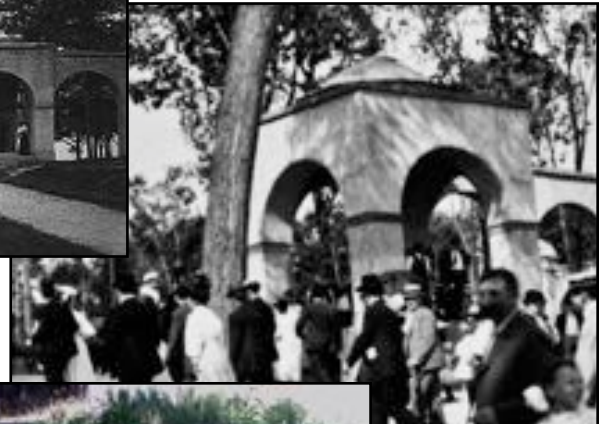
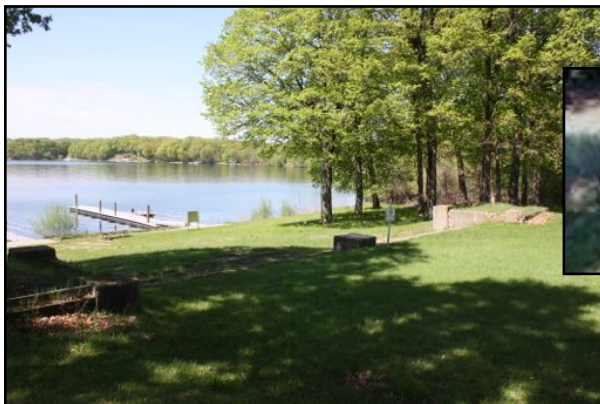
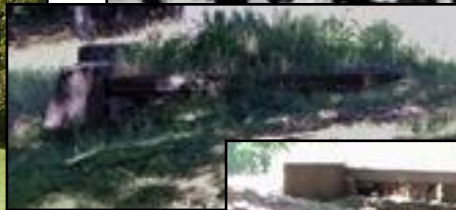
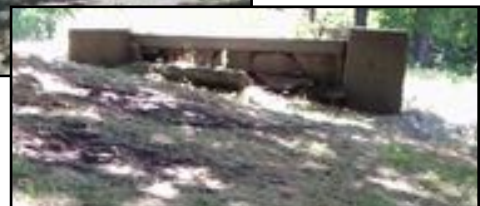
The Mission Revival Gazebos under construction, during the Big Island days, and in 2019 (Buffington BmB869; MNHS MH5.9ORp14; HCL P12304; MHM).

The east and west Gazebo Bases that lie on either side of the Landing Steps once supported Mission Revival Gazebos that offered shaded 'waiting rooms' near the Steamboat Landing. The Gazebos had domed roofs supported by sturdy arches; in 2019 they measured 15.30' square. Heading to the east and west from the Gazebos, curving Mission Revival decorative archways led BIAP patrons away from the Steamboat Landing; these Archways supplied some shade simply by their existence, but they are not a true arcade, blind arcade⁴ or peristyle⁵.

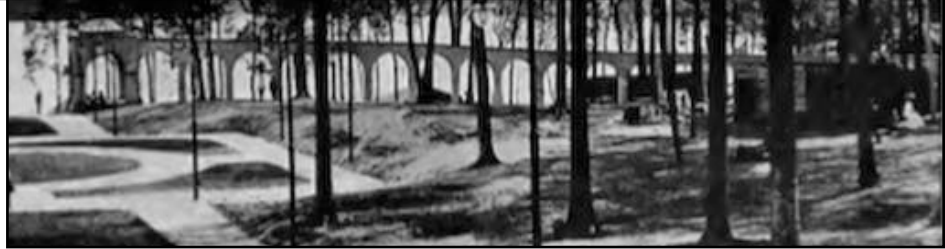
3D scans and an image of Archway 1 (MHM).

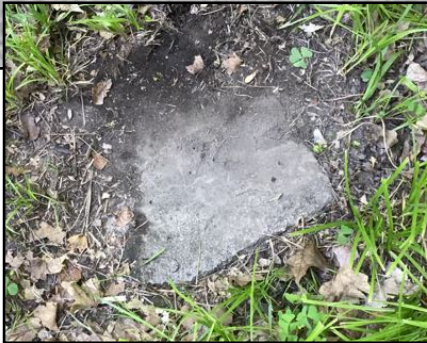
This *in-situ* concrete block is physical evidence of the BIAP Boat House (MHM).

The BIAP Boat House is located west of the Steamboat Landing; it is comprised of 1 *in situ* concrete block. In consideration of the Sanborn Map and contemporary images, MHM has concluded this feature is the BIAP Boat House. Records indicate the Boat House was 11.00' by 20.00' in size and it was constructed of wood. The BIAP staff and patrons used the Boat House as a storage unit for oars and other items that were needed to operate and enjoy the dozens of Rowboats owned by the Park (Russ Olson 1976, 203). During the BIVC years, a small wooden shed was constructed on the footprint of the Boat House, and a garage-style boat house with a sliding barn-like door was built next to the shed on the west side.

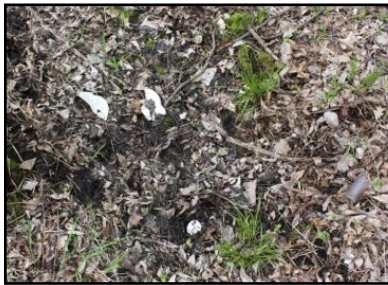
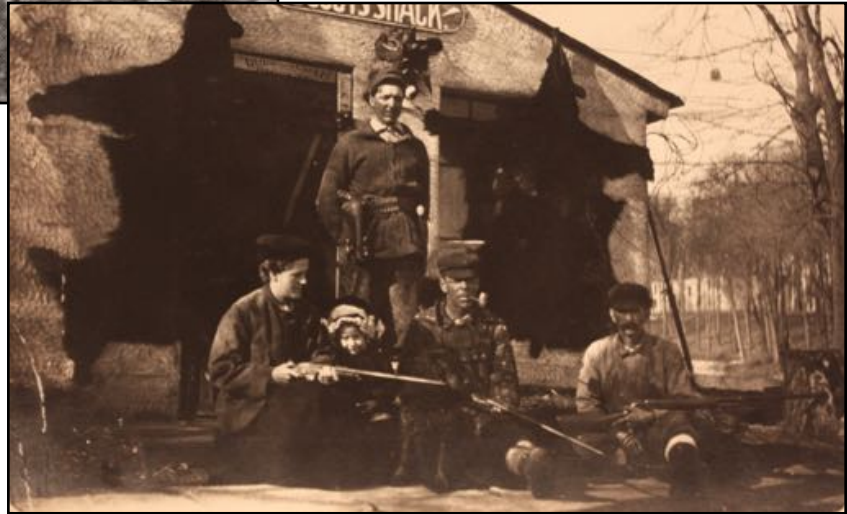
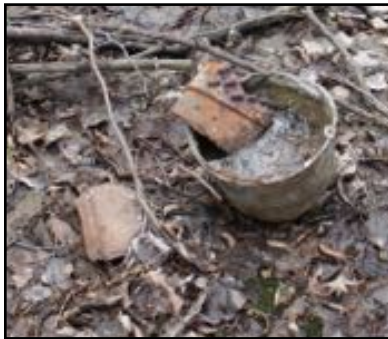
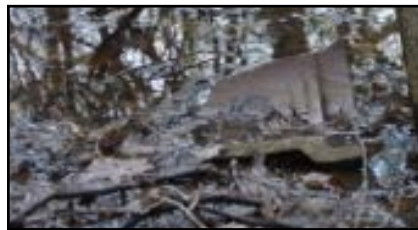
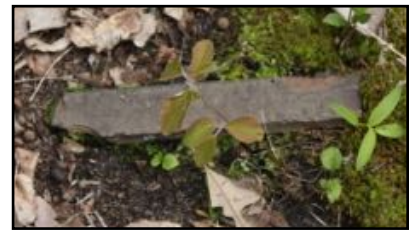
Staff Kitchen Middens 1-4, artifact scatters located on the western side of the project area (MHM).

The BIAP Staff Kitchen was a large 69.00' by 20.00' wooden building constructed in a L-shape (Olson 1976, 203). Historically, MHM has located 1 and possibly 2 photographs of the building⁷ and archaeologically, the structure survives as artifact middens Staff Kitchen Middens 1-4 (SK Midden1-SK Midden4). The Sanborn Map recorded the footprint of a building in the proposed location of the Staff Kitchen, but it does not agree with the reported dimensions of the building or the photograph. However, MHM contends it is highly likely the artifactual and photographic evidence support our supposition for the placement of the feature. (State Game and Fish Commissioner 1916, 34).

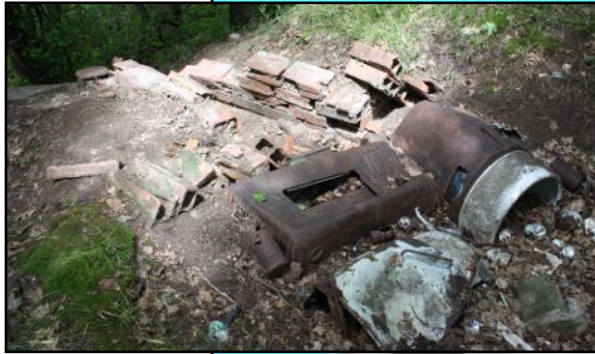
MHM's 3D scan of the Large Drain.

The Large Drain allows for a thorough study of the construction techniques and materials for the BIAP buildings (MHM).

The exposed nature of Feature D6 on the western side of the project area is particularly helpful from an archaeological standpoint; studying the construction of this Large Drain assisted MHM in understanding other similar, smaller structures around the project area. Feature D6 is comprised of a rectangular ditch with a channeled outlet on the western end that is formed from 2 walls of architectural terra cotta bricks, concrete, and mortar. The channel walls widen and flare outward to accommodate the water it is meant to drain away from the BIAP structures. The northern wall is damaged where it begins to flare outward; it is slowly being upheaved by a large tree growing nearby and its roots are pushing the brick wall upward and over. Many pieces of broken concrete slab and terra cotta bricks surround the area; again, moved about by tree roots. On the south end of the channel wall, prior to its widening out, 2.00" by 4.00" pieces of wood were embedded vertically on both the north and south corners. One of these wooden pieces is *in situ* and the other was dislodged and broken in 2 pieces; it is lying slightly downhill from its original position along with loose terra cotta bricks. The rectangular ditch has been used as a landfill over the decades. People have thrown not only pop, coffee, and beer cans and bottles into the hole, but vintage washing machines (2) and a

furnace. One of the washing machines has a control panel that is imprinted with the name 'Sears Lady Kenmore'; it is round, has a wringer, and dates to the 1940s. It is probable that the appliances and furnace were once components of the BIAP Staff Kitchen. MHM does not know if the rectangular portion of Feature D6 is lined with concrete; that question would be answered with a Phase II or Phase III archaeological investigation. MHM 3D scanned and recorded the position of the Large Drain.

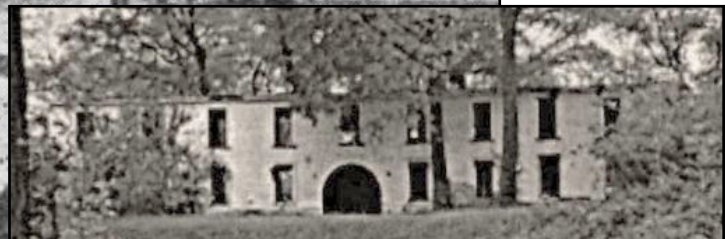
3D scans of MDormF2 (top), MDormF3 (bottom), and images of them. Note the remnants of terra cotta brick on MDormF2 (MHM).

Located near Features A2, A3, and A4, the Men's Dormitory building, Feature MDorm - Men's Dorm Foundations 1-3 (MDormF1-MDormF3), Men's Dorm Pavement (MDormP), Men's Dorm Middens 1-3 (MDormM1-MDormM3) - housed the male employees of the BIAP. These features represent the *in situ* and midden remains of the Men's Dormitory. The northernmost area of Feature MDormF1 is a foundation block that may mark the location of the front door, a room division, or the end of the building. The building was constructed using architectural terra cotta brick and concrete, had 2 stories, and reportedly measured 85.00' long by 28.00' wide (Olson 1976, 203). After the BIAP closed, the Dorm remained intact and was used by the BIVC as a barracks when the camp opened in 1921. MHM is confident that the majority of the building's foundation and concrete floor are intact under the surface matrix, particularly since the Dorm stood until 1987. Further fieldwork would answer this and other questions.

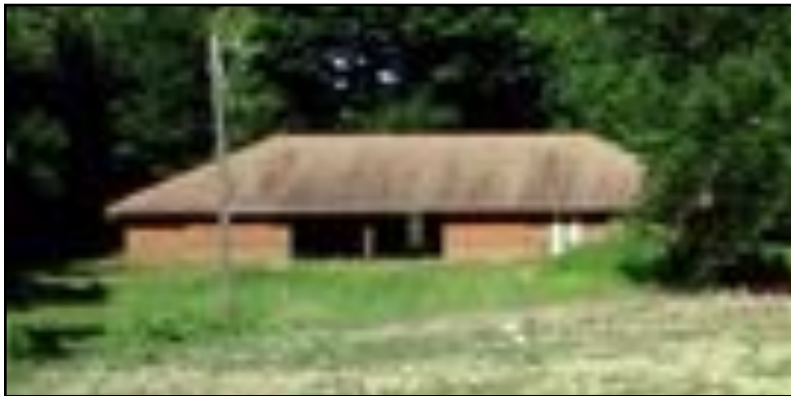
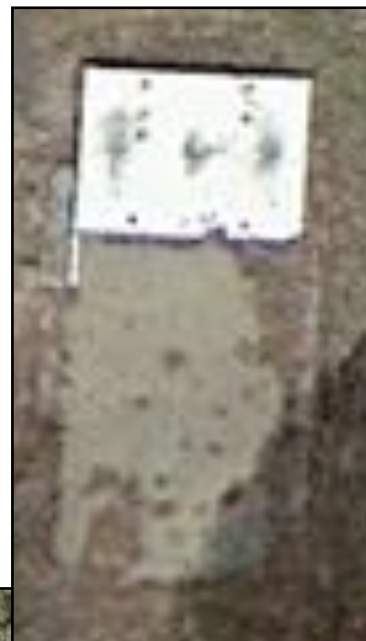
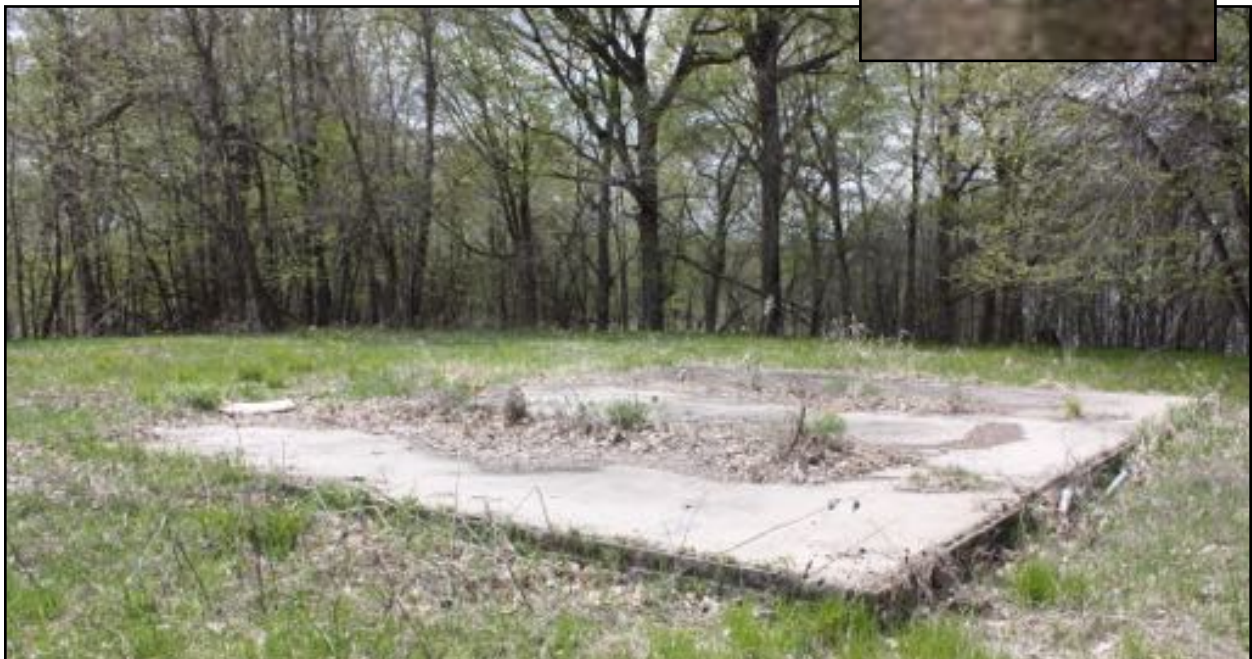
Above: The Bathroom Building as it looked in 2007 (MHM).
 Right: An image taken soon after the building was torn down (Google Earth). Below: The Building Foundation and Floor in 2019 (MHM).

Near the Men's Dormitory, slightly to the southeast, a BIVC Building Foundation and Floor (Feature T4) are extant. As seen in an aerial image from 1971, the foundation was larger at that time, suggesting a big building had been constructed there by the BIVC. In 2007, during the BISI Project, a bathroom building stood on the spot; it was torn down between 2010 and 2012. A 2012 aerial image of Feature T4 clearly indicates the foundation floor had a series of holes for toilets; the other 2/3 of the floor appeared to be compacted earth, but still obvious. This section of the foundation floor is not evident, but a paved sidewalk to the east of that footprint does survive. Photographic images of the BIVC from the 1930s and 1940s would be helpful in answering questions about Feature T4 and by association, the Men's Dormitory (MDorm).

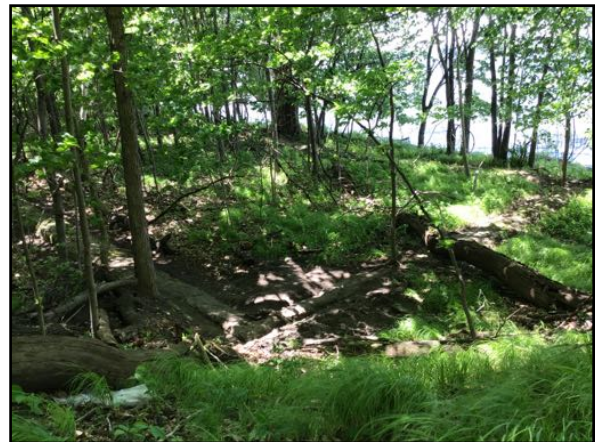
MHM located the intact rectangular foundation of a large building - the Ice House - early on during the 2019 fieldwork. Based on its location, MHM has determined it was the BIAP Ice House that had a small Ice Cream Factory attached to its southwest side (Sanborn Map Company 1912). The Ice House was 50.00' long and 40.00' wide; the Ice Cream Factory appeared to be a smaller rectangular wooden building was approximately 20.00' long by 10.00' wide. The Ice House had a substantial concrete foundation, 1 story, and was constructed of wood. The absence of *in situ* or broken terra cotta bricks in the matrix attests to the construction method used for the building. Further, MHM probed inside the building's foundation and did not locate a poured concrete floor, further negative evidence that supports the Ice House identification. Lastly, records indicate that the Ice House also had a horse barn associated with it (Olson 1976, 203), but no archaeological evidence of this structure was identified.

Above: The Ice House foundation can be seen - after cleaning - from the ridge above it and to the northwest (MHM).

Below: The southeast corner of the Ice House (MHM).

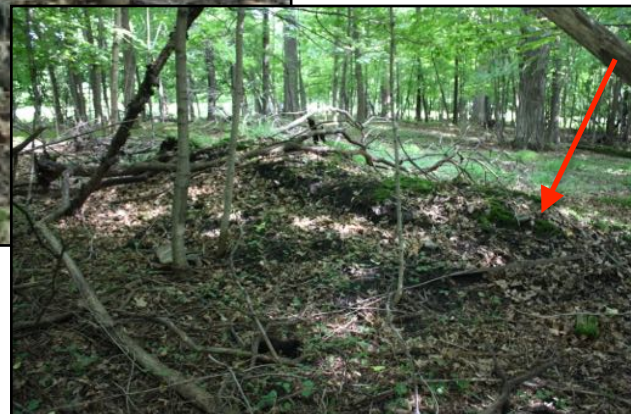
The arrows are pointing out the earthenworks of Toilet 1 that are basically large artifact middens mixed with matrix. A number of large artifacts are evident in the area as well, as seen in the image above (MHM).

Originally, Toilet 1 (T1) was located near the Men's Dormitory; MHM suspects T1 is the Men's Toilet, but its destruction does not allow for proper analysis of the structure. However, the Men's Toilet was 1 story tall, 36.00' long by 27.00' wide, and built using terra cotta brick, concrete, and stucco (Olson 1976, 203). MHM could not document the building's foundation *in situ* because the T1 currently lies in a mound-like earthworks and large midden scatter, including the T1 Midden. T1 remained standing for decades after the BIAP closed, probably as a toilet facility for the BIVC. The last visual confirmation MHM has identified - through aerial photography - of a still-standing T1 is dated November 9, 1971 (John R. Borchert Map Library 1971).

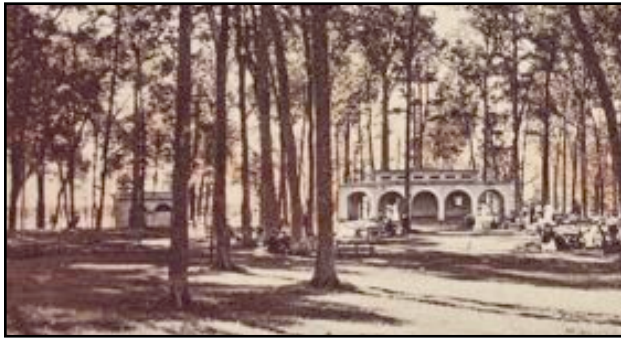
Toilet 1 and Picnic Kitchen 1 (ELMHS)

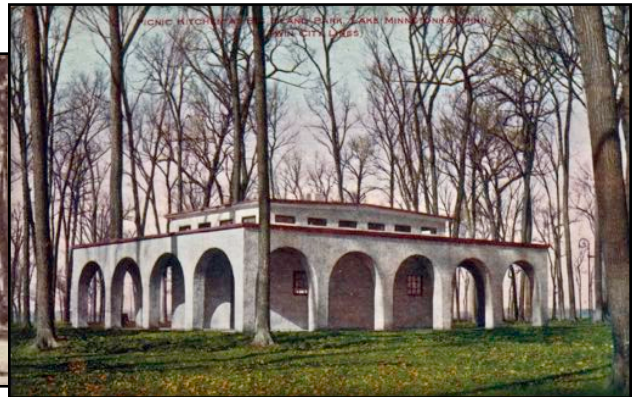
Picnic Kitchen 1 (MHM).

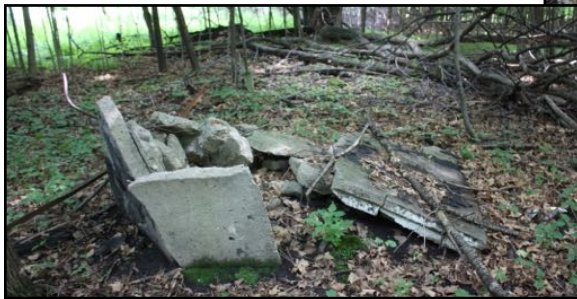
Feature K1 Original represents the site of Picnic Kitchen 1 that lacks significant artifactual evidence of the building. However, Feature K1 constitutes a large midden of upheaved demolition rubble that made up the foundation floor for one of BIAP Picnic Kitchen1. It is located just to the northeast of the original location of Picnic Kitchen 1. Originally the building was 29.00' long by 20.00' wide, not including the Mission Revival Archway Portico that surrounded the building.⁸ Picnic Kitchen 1 was rectangular with a slightly peaked roof and clearstory windows on all sides and the portico produced a walkway and shade around the building. The kitchen's exterior surface was completed with stucco and the roof - both on the building and the portico - was tiled with rounded terra cotta tiles. Picnic Kitchen 1 was constructed on a high and flat section on the northwestern section of the BIAP grounds. Feature K1 is comprised of large flat metal-reinforced concrete slabs - no longer *in situ* - that were dumped into a big pile along with metal straps, terra cotta bricks, electrical materials, shingle remains, and a possible Archway base. Feature K1 Midden is another, smaller collection of building materials associated with K1. The BIVC utilized Picnic Kitchen 1 for decades after the closing of the BIAP; at one point it was used as a multi-truck garage (Maravelas Chapter 12). Like Toilet 1, MHM identified a still-standing Picnic Kitchen 1 in an aerial photograph from November 9, 1971 (see above).

Two views of Feature K1(MHM).

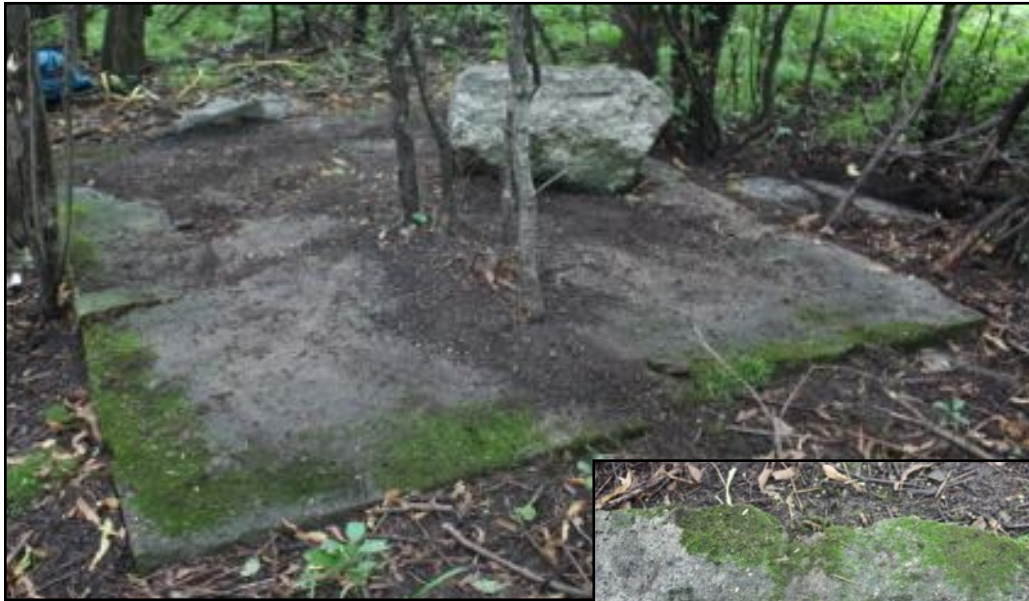
A small 11.00' by 7.50' concrete slab located northeast of the BIAP Feature K1 - with a large rock on top of it - was once a small building. The concrete has impressions of metal I-beams imbedded in it and the corners are notched for vertical 2.00" by 4.00" wooden corner framing. Several small trees have broken through the slab, breaking it into pieces. Apparently 'Paul' finished pouring the concrete base at 8 PM on a day in 1970, according to the message set in the floor. Remnants of its fiberboard walls, a metal grate, window and/or door screen, and asphalt roof shingles are associated with Paul's Pavement. Other artifacts are nearby, including broken bottles, beer cans, and an old metal mop top. MHM does not know when the building on Paul's Pavement was torn down.

Paul's Pavement images and 3D scans (MHM).

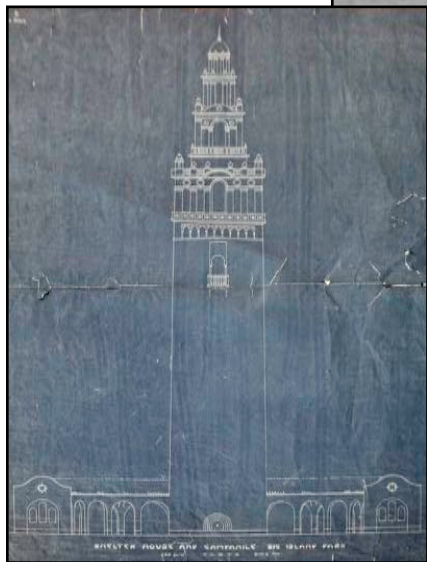
To the southwest of the cabins and trailer described above, a hill with the highest elevation in the project area was the location of the BIAP Water Tower, Well, and Shelter. The construction was described as including "an artesian well 400 ft. deep, furnishing a fine water supply, and we store our water in a steel tower covered with concrete and studded with electric lights. This tower is a close copy of the famous tower of Seville, Spain, and makes an attractive ornament to the island. At the base of the tower there is a shelter house" (Warnock 1908, 108). The Shelter House emulated the Mission Revival Archways and was in reality, a semi-circular arcade with doors on either end. The Water Tower was 186.00' high with a 25.00' square base. When the BIAP closed, the Tower remained standing for a time and was described during a winter train ride west to Hutchinson. The train's passenger concluded that "a vast plain of dazzling whiteness that is recognizable as Lake Minnetonka only by familiar islands and distant points and the faraway symmetry of the crumbling Spanish tower on Big Island"; the Water Tower remained an icon on the lake beyond its use as part of the BIAP (Storrs 1917). It was reported that the Water Tower was "cut loose and collapsed" during the winter of 1918 by a local work crew, and the scrap metal produced went over the ice to Deephaven for recycling (Elwell and Elwell 1975, 16-17). During 2019, MHM located 2 blocks of Tower/Shelter concrete - the *in situ* TS FoundationBlock1 and the dislodged TS FoundationBlock 2. Further, 2 middens (TSMidden1-2) may be associated with the destruction of the Tower and Shelter.

The blueprint of the Water Tower and Shelter (Buffington 1906).

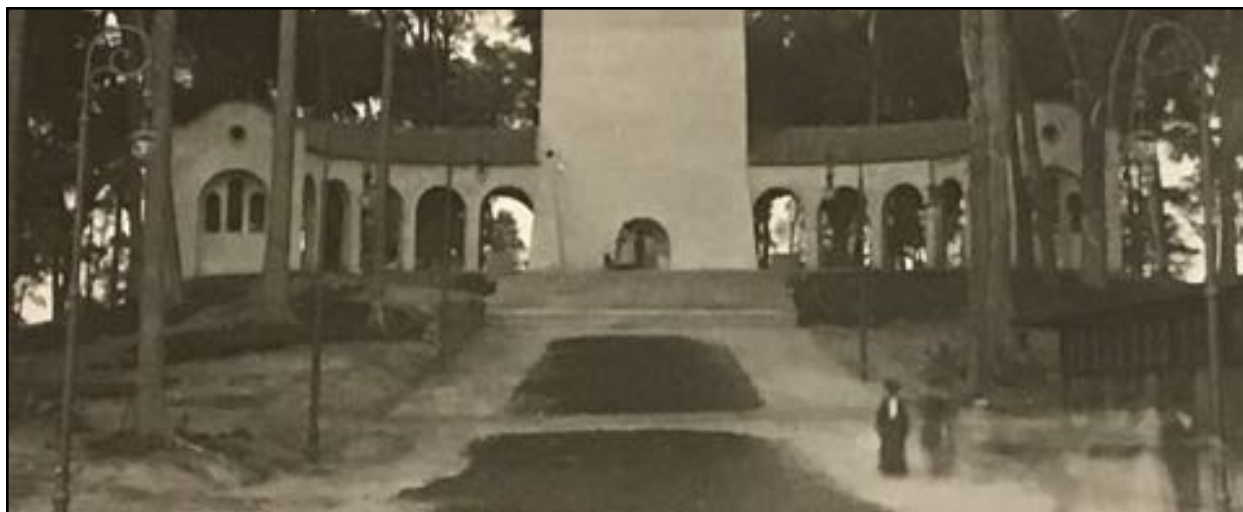
The Shelter as seen from The Mall (MNHS MH5.9ORr2)

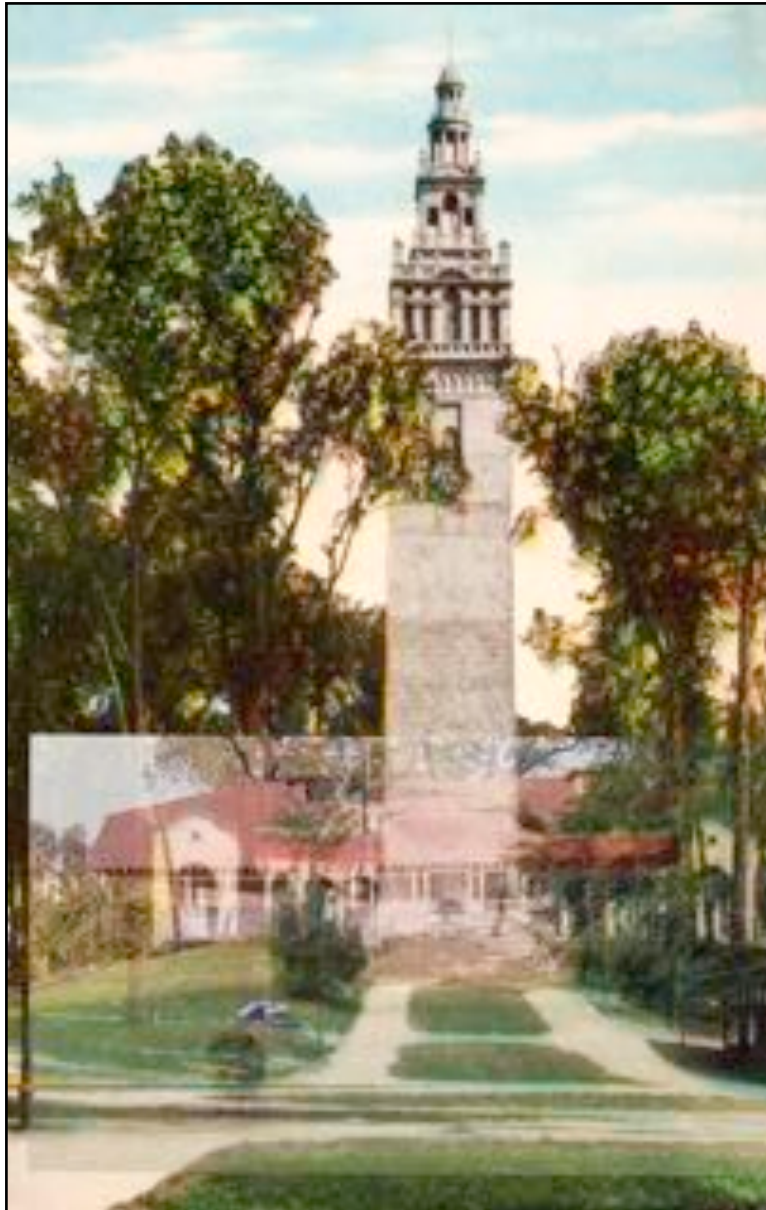
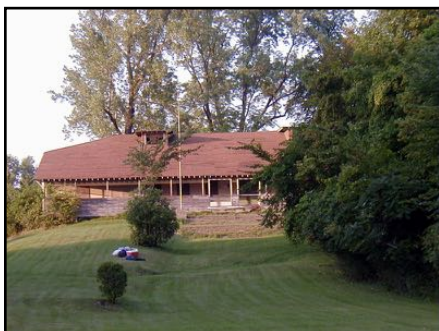
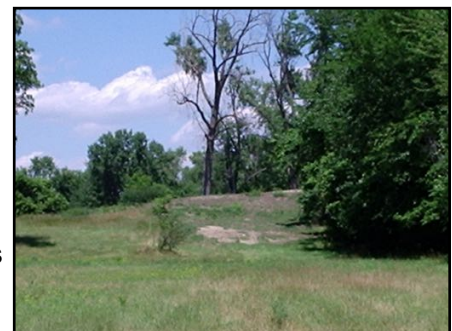
On the same site, the first BIVC Mess Hall was constructed in 1920 and it was destroyed by fire in 1924; many tents were stored in the building as well, and they were a complete loss (Grim 1965). The 'new' BIVC Mess Hall, also constructed on the footprint of the Water Tower, was a framed wooden structure with a large front porch. The building was situated with the front entrance to the south, aligned with the concrete stairs that still survived from the BIAP Water Tower. Also, the BIVC used the Well throughout its history. The Mess Hall stood until it was intentionally burned down in June 2006, and the BIAP concrete stairs were torn out of the ground using a backhoe. As mentioned above, during MHM's archaeological work on the island in 2007, small test trenches on the Water Tower/Mess Hall mound exposed hundreds of small artifacts - along with some larger objects - that are still in the matrix and covered in tall grass. The BIAP well shaft remains under the mound created for the Water Tower and Shelter House, and the large footprint of the BIVC Mess Hall is essentially a large filled-in trench. A Phase II - or possibly a Phase III - excavation of this large archaeological feature could answer questions about the construction of not only the Mess Hall, but the Water Tower and Well. The aforementioned TS FoundationBlock1 and TS FoundationBlock 2 may have been reused by the BIVC in the Mess Hall's foundation

construction. Lastly, Concrete Stairs from the BIVC that led from the rear of the Mess Hall are still located *in situ* and undamaged, leading down the mound to the north.

Above: The BIAP Water Tower and the BIVC Mess Hall superimposed.

Left: The BIVC Mess Hall in 2003 (MHM).

Right: The Water Tower/Mess Hall site in 2007 (MHM).

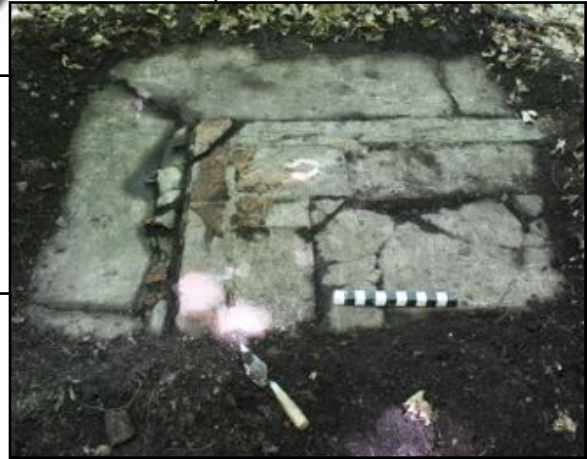
A 3D scan and image of the east corner of the wall foundation, along with the inner concrete floor and the outer concrete pavement of Picnic Kitchen 2. Note the terra cotta brick remnants (MHM).

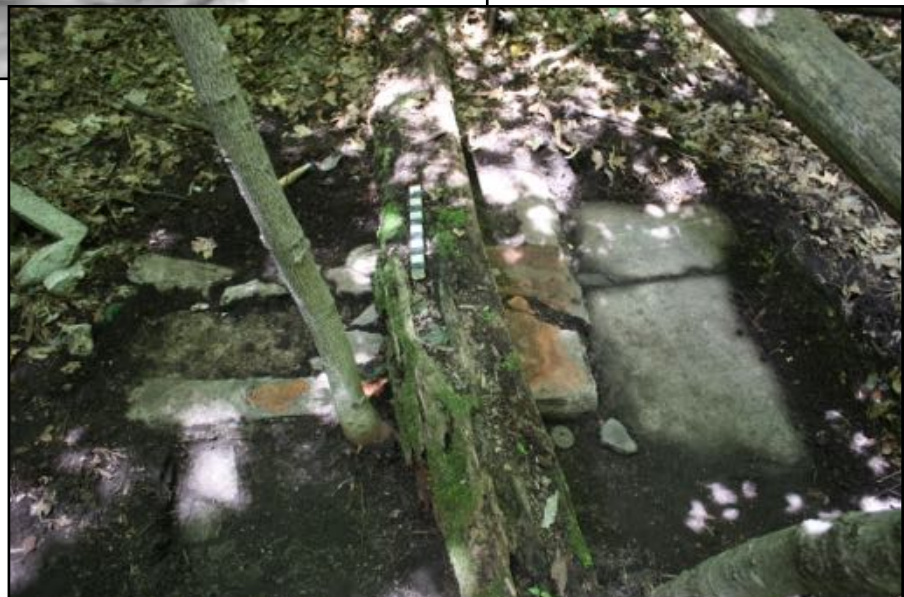
A 3D scan and images of the west corner of the wall foundation, along with the inner concrete floor and the outer concrete pavement of Picnic Kitchen 2 (MHM).

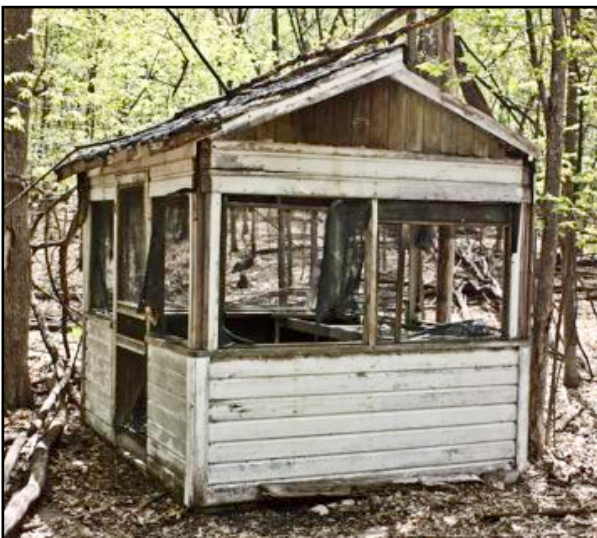
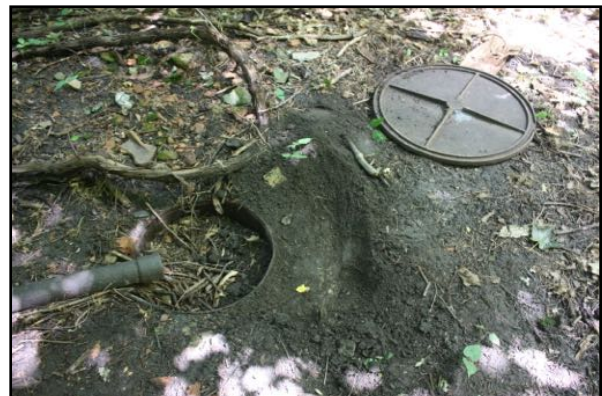
Left bottom: The BIVC Fish Shack (MHM).

Below: BIAP drain D3 (see below) re-used by the BIVC (MHM).

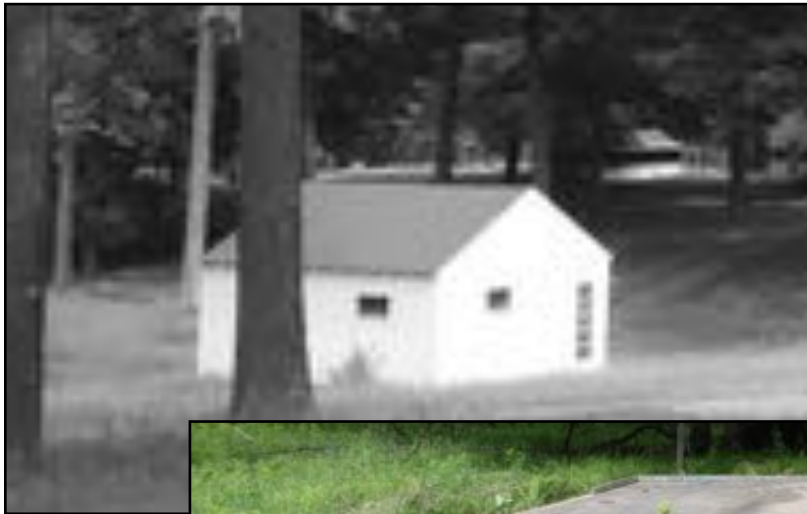
South of Feature K2, a concrete platform with several holes formed into its base, represents the remains of Feature T2 - the BIAP Toilet 2. Originally Feature T2 measured 20.00' by 20.00' and was constructed of terra cotta brick and concrete to resemble the Mission Revival Archways and stucco construction of the other BIAP buildings. At some point, the BIVC dismantled the building's walls, laid down concrete bricks around the periphery of the foundation, poured a new concrete floor, and constructed a new bathroom structure out of solid concrete bricks. The new floor respected the drainage holes for toilets - and maybe some newly installed shower stalls - and it was painted blue. The BIVC renovation may have included the addition of another entrance to the building, allowing for the partitioning of the building into distinct toilet and shower areas, and/or divide the building into 2 spaces for different genders. MHM suggests this conclusion because Feature T2 had 2 entrances across from each other on the north and south sides. On the north side a rectangular step provided a firm foundation to step into the building on that end. The south side, 2 steps allowed access into the building; MHM does not know if these attributes are original to the BIAP version of Feature T2 or if they were formed by the BIVC. At the northeast corner of the building, an *in situ* BIAP metal pipe runs north to south and parallel to the foundation. Another BIAP metal pipe protrudes 12.00" out of the ground and about 18.00" from the northeast corner of Feature T2. Just to the south of the vertical pipe, a 'modern' PVC pipe with 2 hose clamps attached to its end lies loosed on the ground. MHM 3D scanned the entirety of the Toilet 2-BIVC Bathroom; the BIVC Bathroom was torn down by 2007. MHM 3D scanned Feature T2 during the 2019-BI Project.

The BIVC Bathroom in 1955, constructed on the original footprint of BIAP Toilet 2 (ELMHS).

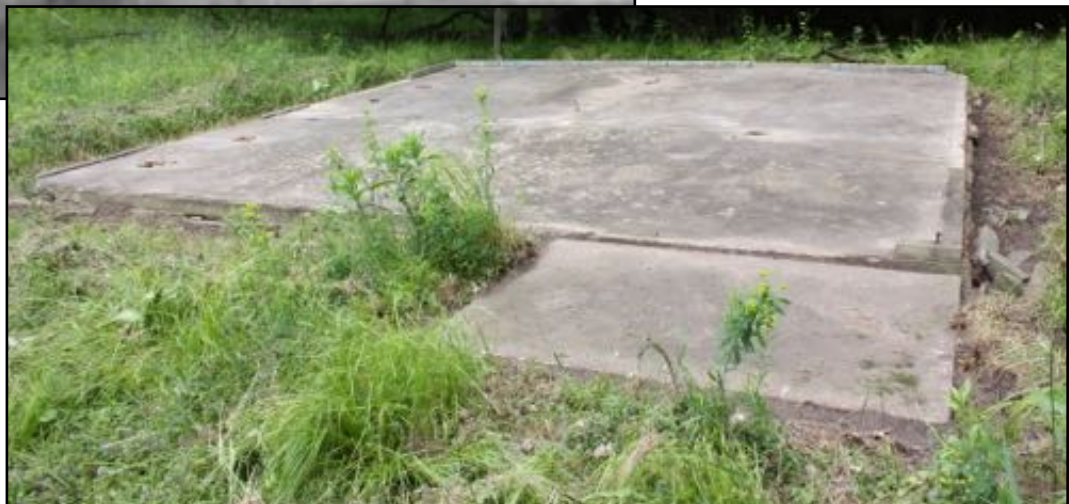
The concrete slab floor of BIAP Toilet 2 with the BIVC Bathroom floor poured on top of the original (MHM).

3D scans of BIAP Toilet 2-BIVC
Bathroom (MHM).

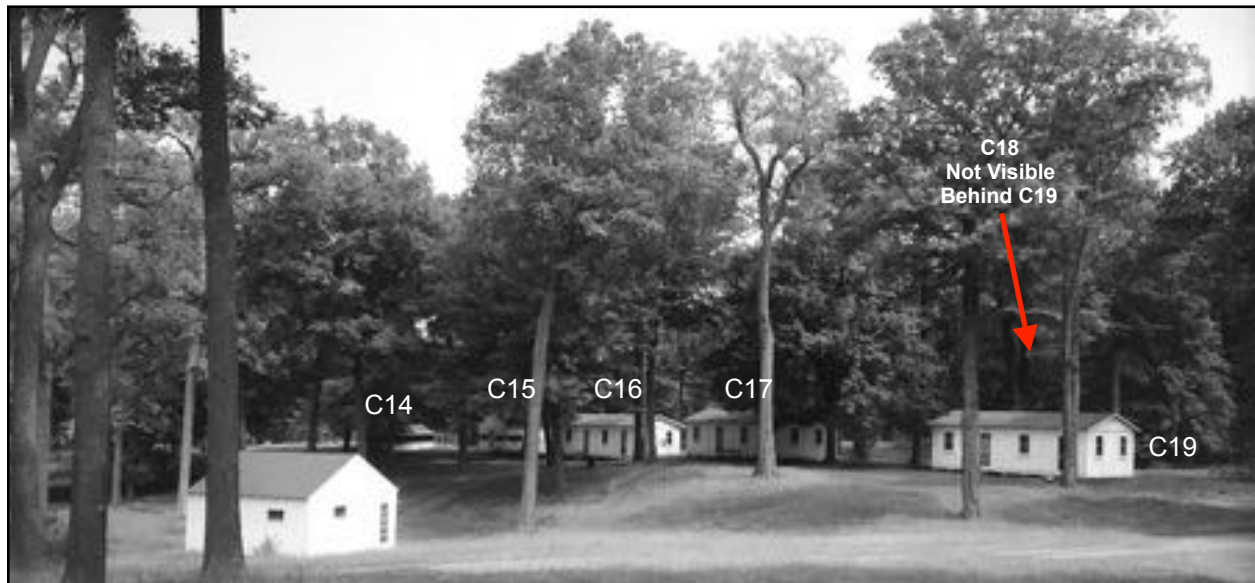
To the east of BIAP Women's Toilet 1-BIVC Bathroom feature, MHM identified an additional 6 cabin features. Three of the features (C14, C15, C18), based on the archaeological evidence recorded in those areas and compared with photographic images, were originally of the tent cabin type. However, Feature C14 left no physical evidence behind, only photographic, and it appears that Feature C18 was burned. Features C16, C17, and C19 are represented as a series of artifact middens and *in situ* building foundations. Further, C15, C16, and C17 incorporated BIAP building materials within them; C16 is currently comprised of an L-shaped concrete building foundation associated with BIAP terra cotta tile and concrete. This relationship indicates the BIVC construction workers utilized BIAP materials that were available and useable in their new structures. MHM does not know when Cabins 14-19 were demolished, but Cabins 15-19 were extant in an April 1962 aerial photograph, and Cabins 15-17 and 19 still stood in 1971 (John R. Borchert Map Library 1962, 1971).

The BIVC Bathroom is located on the left side foreground of the image. There are 5 cabins visible in the image above; C18 is behind C19 (ELMHS).

The BIAP re-used concrete slab step and the BIVC cinder block 'stilts' of 'cabin tent' C15, and porcelain artifacts from C19 (MHM).

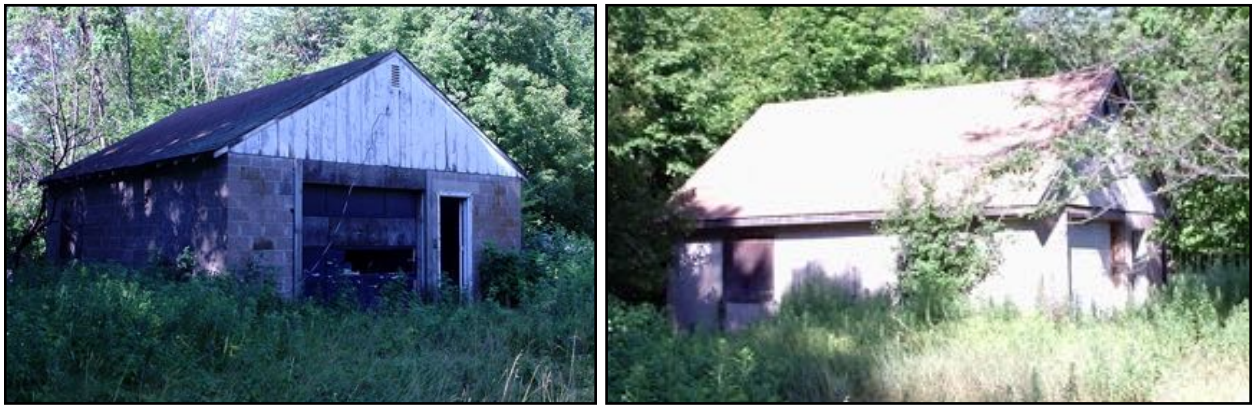
South of Feature T2, 2 concrete floors/platforms are located at the edge of the clearing that extended east of the Water Tower. The eastern-most platform - Feature G2 - currently supports a steel storage unit that houses the island's lawn mower. In 2007 MHM photographed exterior and interior of the cinder block garage that stood on the foundation. To the west, Feature G1 was a garage with a stucco exterior; it was also standing in 2007. Further west, the BIVC Cook's Cabin (Feature CC) was not constructed on a concrete slab, but the building stood for decades and it survives in the form of a midden. Another small building can be seen in a 1988 architect's rendering of the BIVC, but MHM has never seen this building and it is hard to discern from the trees in historical aerial photographs. MHM determined where the Small Building was located and identified the Small Building Middens 1 and 2; they consists of 2 mixed material middens that have a toppled brick chimney - that was set onto a cinder block base - as its largest attribute. The building's function is unknown, and it was torn down sometime between 1988-2007. Lastly, a Rounded Foundation south of the Small Building and its Middens, may be from the BIAP or the BIVC; further research into this feature is required before it can be identified.

BIVC cinder block Garage 2 and stuccoed Garage 1 as they appeared in 2007 (MHM).

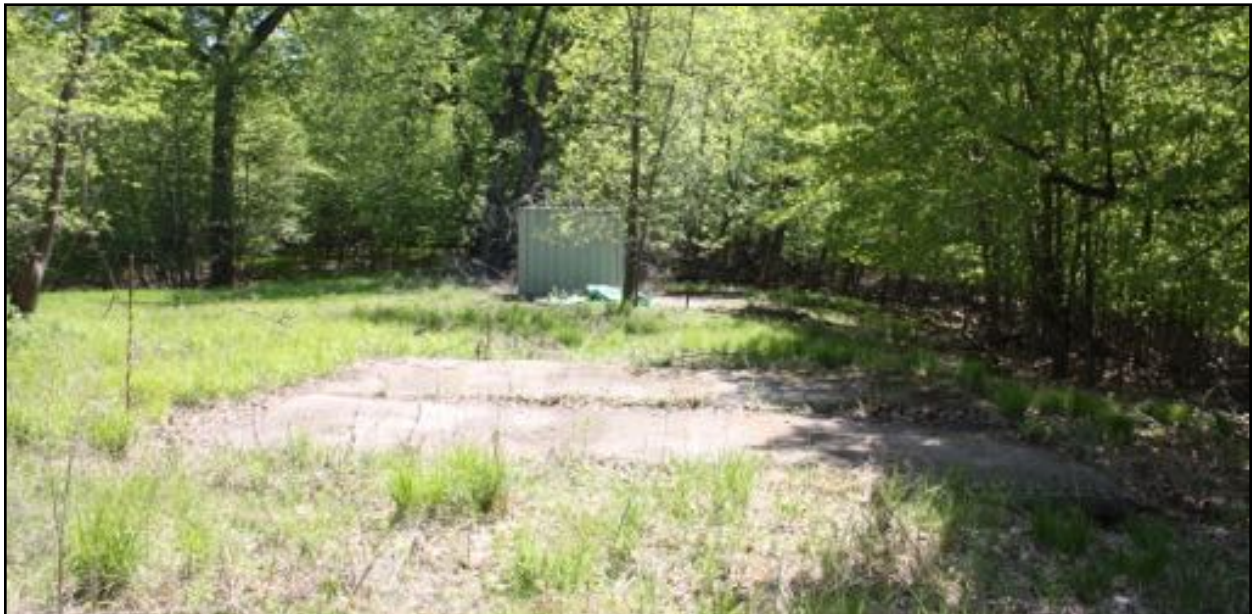
The concrete slab of G1 is in the foreground and the steel storage unit on the G2 foundation is in the background (MHM 2019).

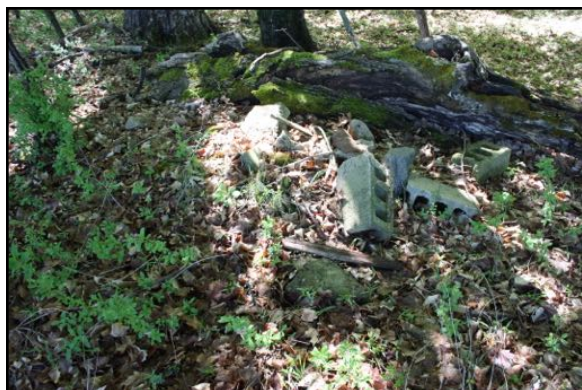
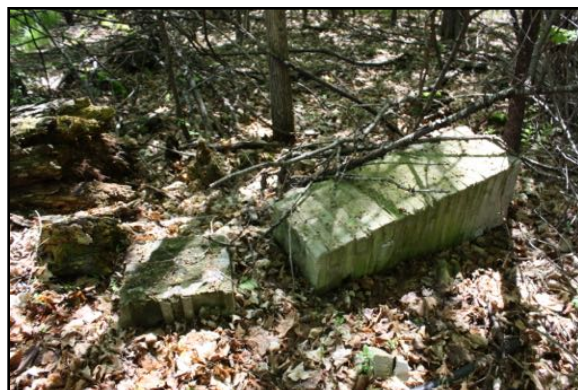
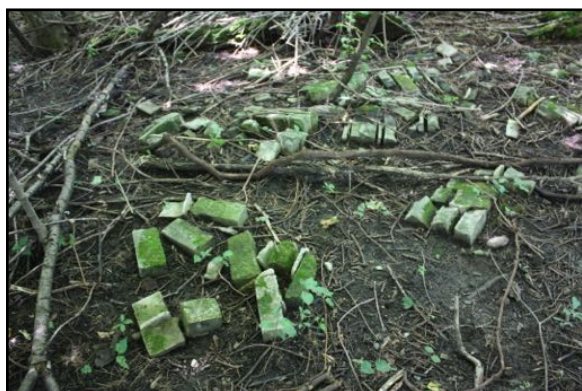
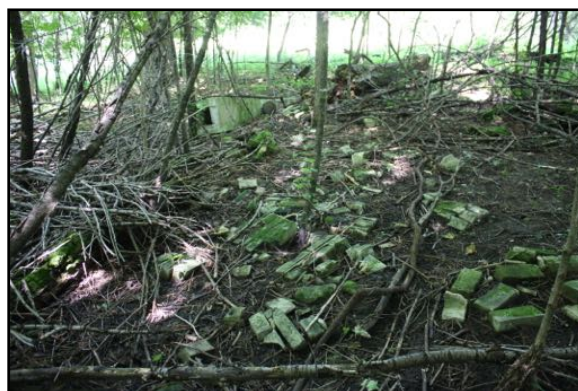
Building construction artifact middens associated with the BIVC Cook's Cabin and an unknown BIVC Small Building (MHM).

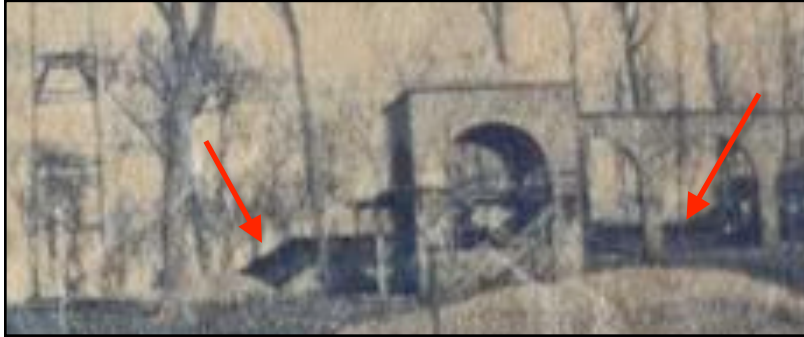
The Refreshment and Dance Pavilion Building was built early-on during the construction of the BIAP and remained in place throughout the life of the Park. It can be seen behind the East Gazebo under construction (Buffington 1906).

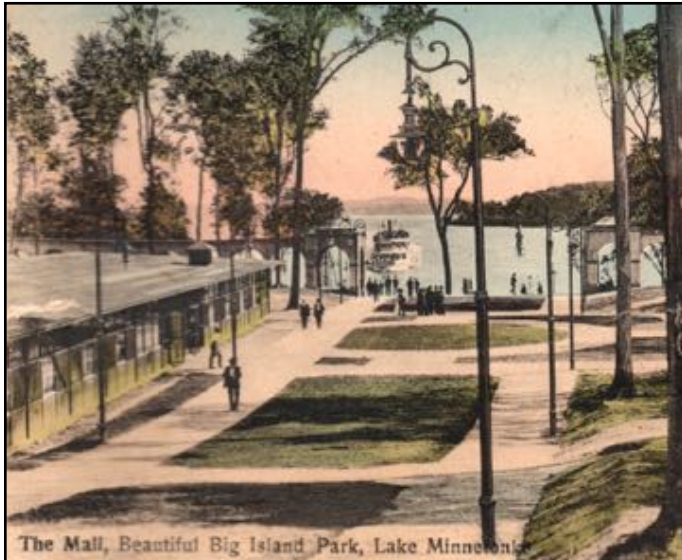
The Refreshment and Dance Pavilion Building is on the left side of this post card. Note the change in The Mall's landscaping where the large circle is seen; it could not be completed because the 'temporary' building became a permanent fixture and the walkway was placed through the circle (MHM Collection).

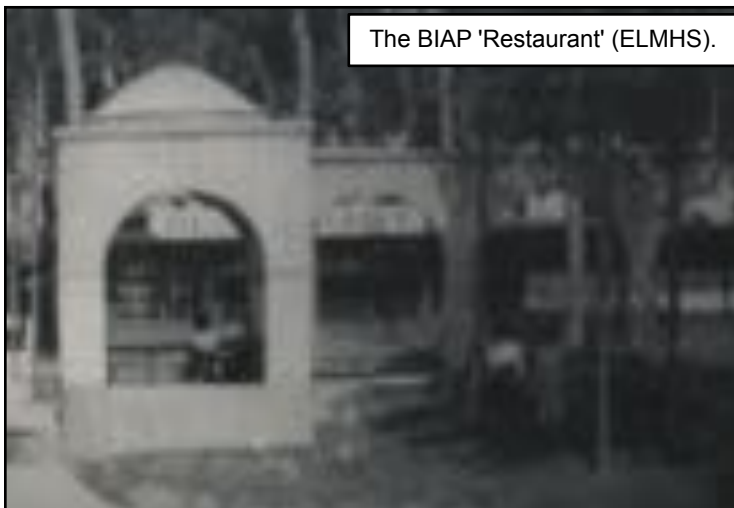
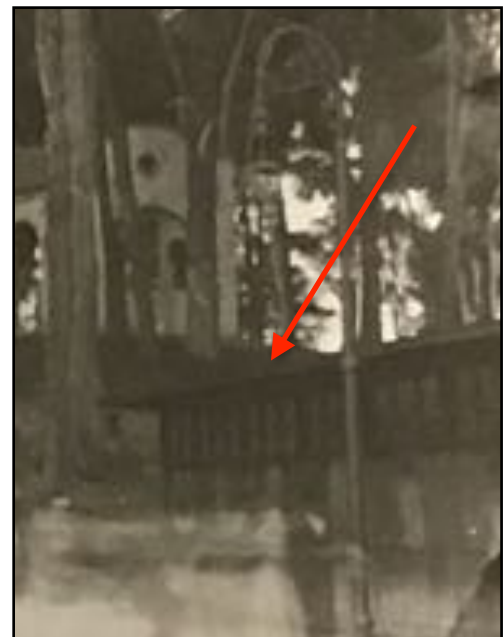
The Refreshment and Dance Pavilion is on the right side of this image; note the 'ghosts' walking by due to a long exposure (MNHS MH5.9ORr2).

The Refreshment and Dance Pavilion entrance pavement is clearly visible in this 1956 aerial photograph (John R. Borchert Map Library).
